# Manhole Inspection Summary

Manhole # S07II1001MH

Insp Date: **5/21/07 11:30 AM**

**Location** Address: **3766 COLUMBUS DR**

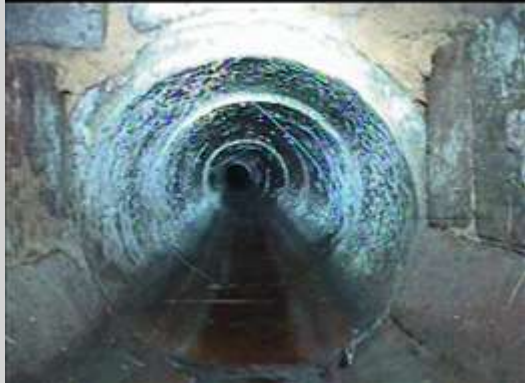
12 O'Clock Outflow

8 in. Circular Gravity Sewer  
Pipe Out @ 12 O'Clock

Invert Depth: **9.37** (ft.) Flow Characteristics: **Slow**

Deposits: ☒ None ☐ Mud ☐ Sludge ☐ **Debris** ☐ Grease

Infiltration: **None** Pipe Seal Cond: **Sound**

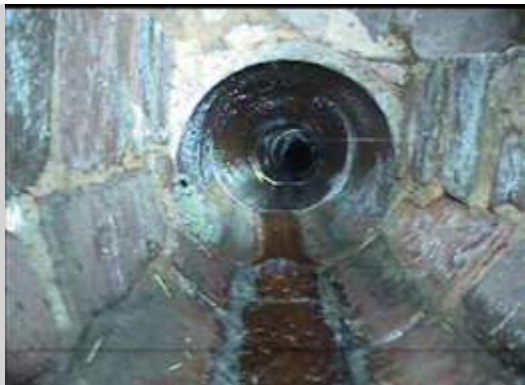
6 O'Clock Inflow

8 in. Circular Gravity Sewer  
Pipe In @ 6 O'Clock

Invert Depth: **9.35** (ft.) Flow Characteristics: **Slow**

Deposits: ☒ None ☐ Mud ☐ Sludge ☐ **Debris** ☐ Grease

Infiltration: **None** Pipe Seal Cond: **Sound**

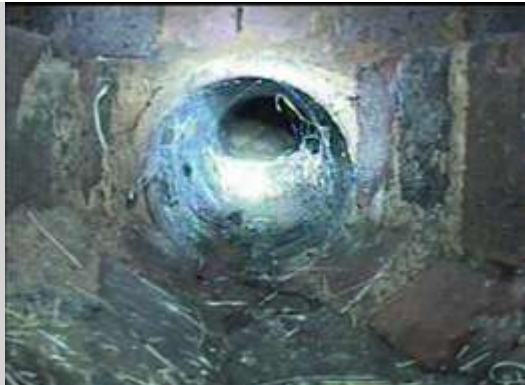
8 O'Clock Inflow

6 in. Circular Gravity Sewer  
Pipe In @ 8 O'Clock

Invert Depth: **9.29** (ft.) Flow Characteristics: **None**

Deposits: ☐ None ☐ Mud ☐ Sludge ☒ **Debris** ☐ Grease

Silt Depth: **0.5** (in.) Deposits Extent: **Medium**

Infiltration: **None**

Pipe Seal Cond: **Sound**
